**PRELIMINARY ASSESSMENT/  
VISUAL SITE INSPECTION**

**ZEXEL ILLINOIS, INC.  
ILD 984 862 383  
AND THE  
FORMER BORG-WARNER CORPORATION  
ILD 005 077 250  
DECATUR, ILLINOIS

FINAL REPORT**

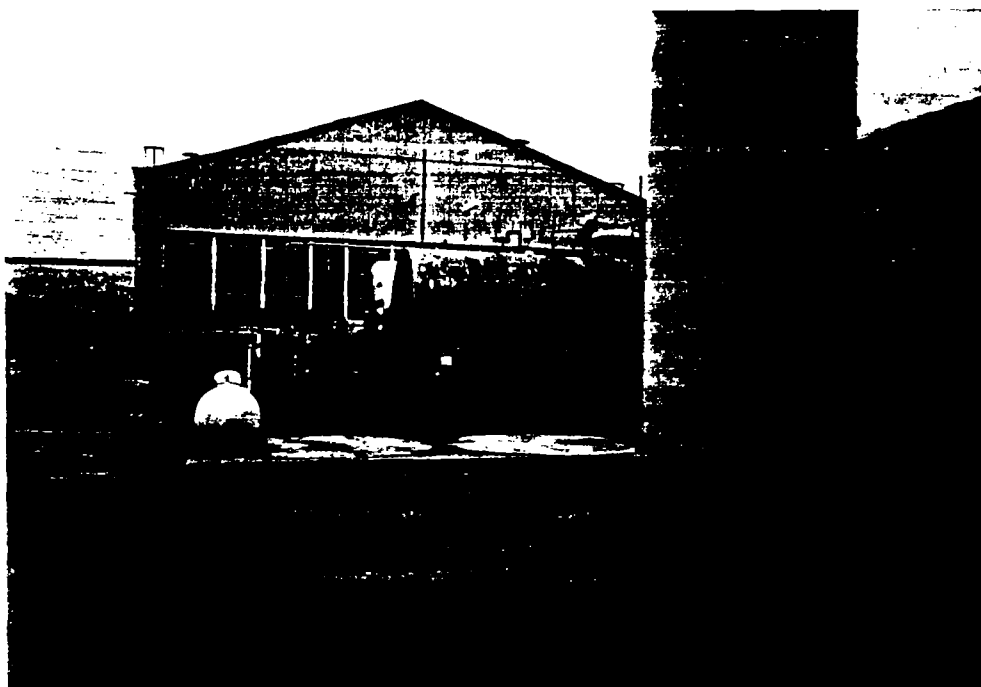
Photograph No. 6

**Observations:** The unit was apparently empty during the VSI. The concrete pad under the AST was clean and without cracks; however, the pad does contain cracks under other tanks also located within the containment structure. RAI noted no evidence of release (see Photograph No. 6).

Location: SWMU 6

Description: The Waste Freon AST is the horizontal tank located at the center of the photograph. This unit was undergoing RCRA closure with IEPA approval at the time of the VSI.

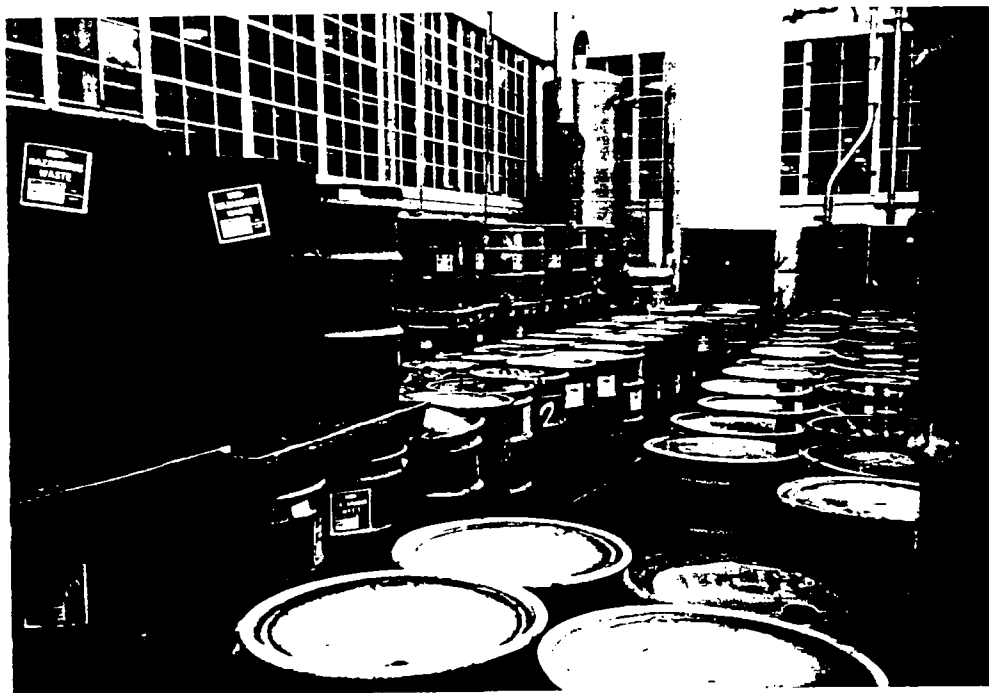
Photograph No. 7

Location: SWMU 7

Description: The Outdoor Drum Storage Area. The drums contain PCB-related material and cleanup waste from on-site remediation activities.

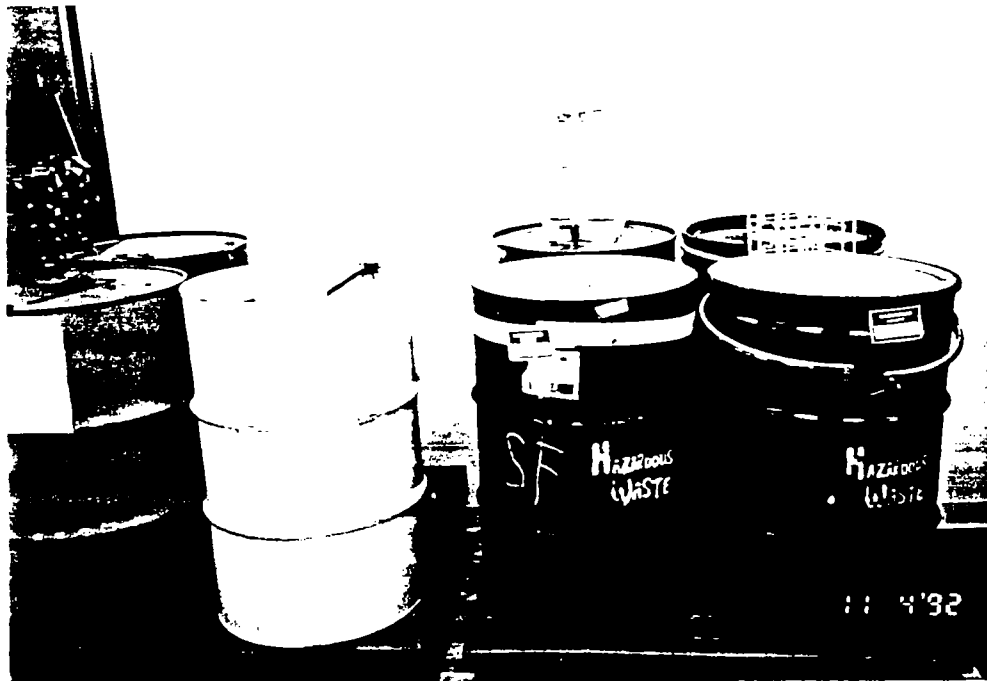
Photograph No. 9

**Observations:** The unit contained 55-gallon drums and containment skids during the VSI. The floors at each location were clean and without evidence of cracks (See Photograph Nos. 9 and 10).

Location: SWMU 9

Description: One of the Satellite Accumulation Areas in the Zexel manufacturing building. Only one drum contains hazardous waste.

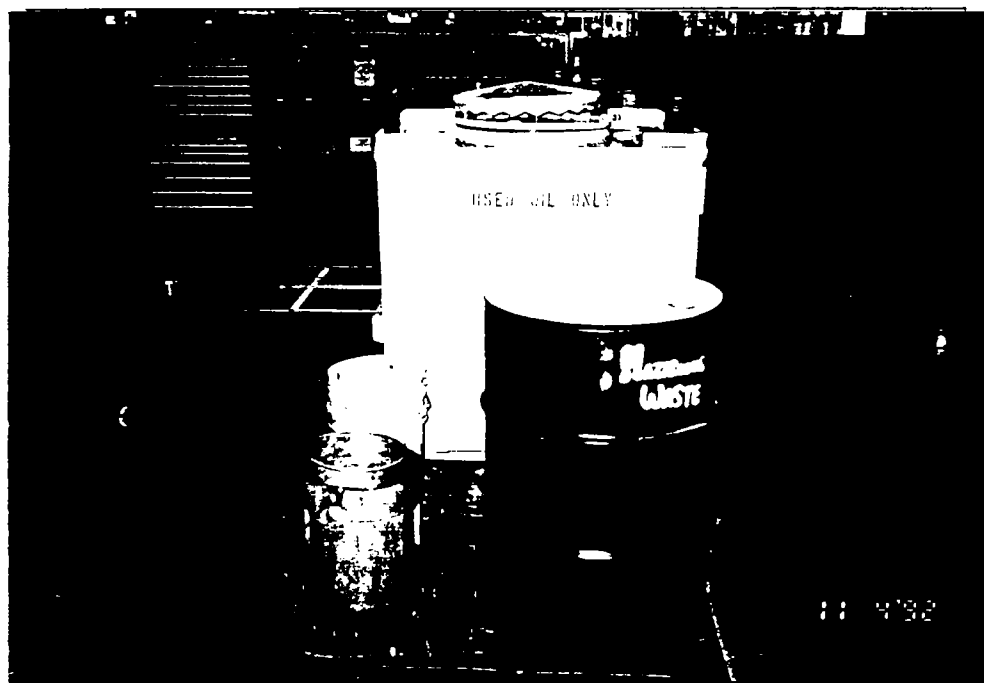
Photograph No. 10

Location: SWMU 9

Description: A Satellite Accumulation Area located in the manufacturing building. Behind this unit is a Nonhazardous Waste Collection Area (SWMU 17) for used oil.

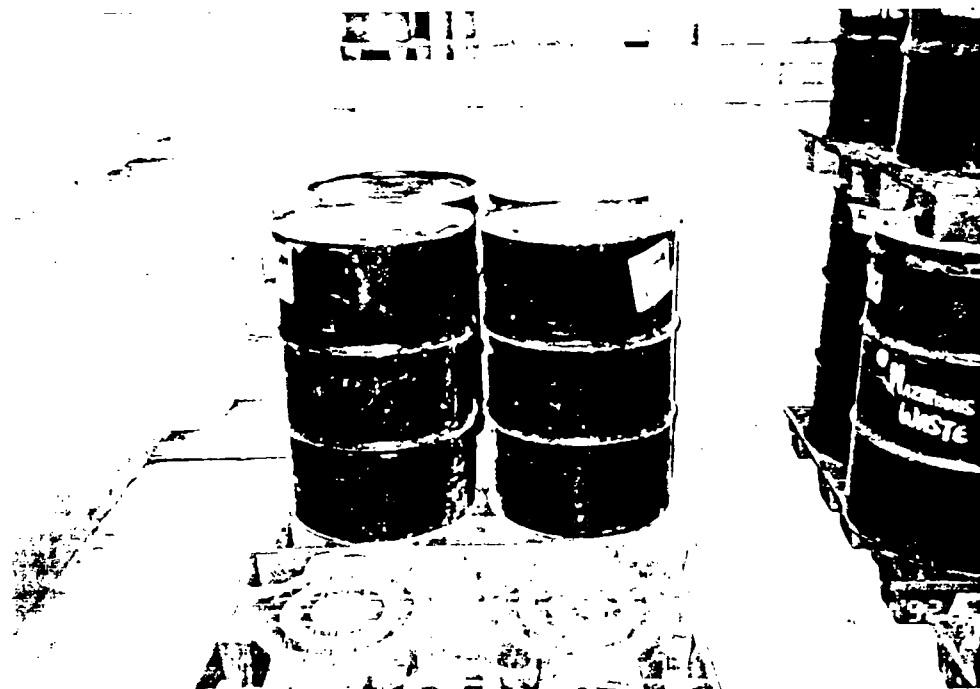
Photograph No. 11

**Observations:** The unit contained 12 drums of hazardous waste and four drums of nonhazardous waste during the VSI. The unit also contained a cardboard box full of scrap metal chips. The floor was clean and without cracks. RAI noted no evidence of release (see Photograph No. 11.)

Location: SWMU 10

Description: The Waste Container Storage Area. This location in the Chip Room manages hazardous and nonhazardous waste.

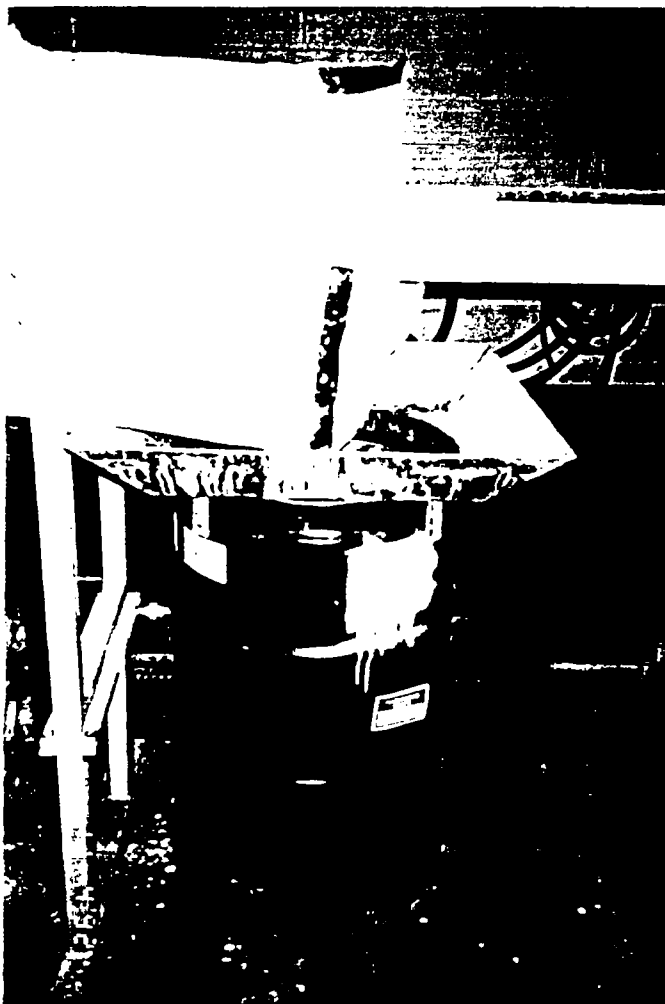
Photograph No. 13

Location: SWMU 12

Description: This is the 55-gallon steel drum that collects nickel filter cake (F019) directly from the Nickel Wastewater Treatment System. A dead sump is visible behind the drum.

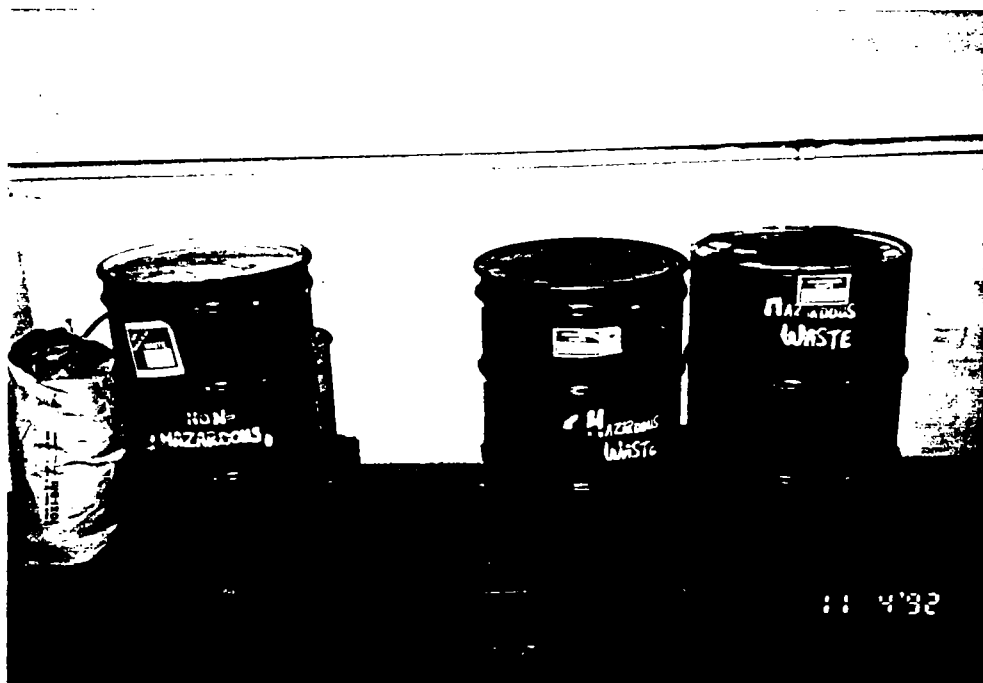
Photograph No. 15

clean and without cracks and RAI noted no evidence of release (see Photograph No. 15.)

Location: SWMU 14

Description: The Waste TCA Storage Area. This area is adjacent to a 550-gallon holding reservoir for storage of waste TCA (F001).
